## Ultrasound Transducer Condition Report

<b>Date Tested</b> 16/10/2020	<b>Carried out By</b> – I. Rutherford
<b>Manufacturer</b> - Philips	<b>Model Number</b> C5-1
<b>Serial Number</b> – B03DKR	
<b>Transducer Type</b> – Convex	
<b>Date of Manufacture</b> - Unknown	
<b>System used to Test</b> – Philips iU22	
<b>Cable</b> – Good	
<b>Lens</b> – Good	
<b>Discolouration</b> - Slight	
<b>Overall Condition</b> – Good	© British Medical Auctions

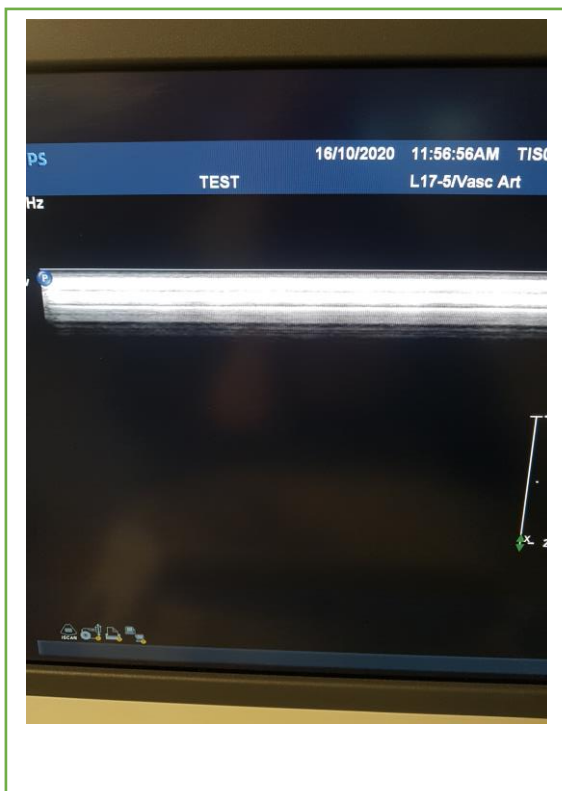
### Airscans –

<b>Date Tested</b> 16/10/2020	<b>Carried out By</b> – I. Rutherford
<b>Manufacturer</b> - Philips	<b>Model Number</b> – L17-5
<b>Serial Number</b> – B02YNM	
<b>Transducer Type</b> – Linear	
<b>Date of Manufacture</b> - Unknown	
<b>System used to Test</b> – Philips iU22	
<b>Cable</b> – Good	
<b>Lens</b> – Good	
<b>Discolouration</b> –Some	
<b>Overall Condition</b> – Good

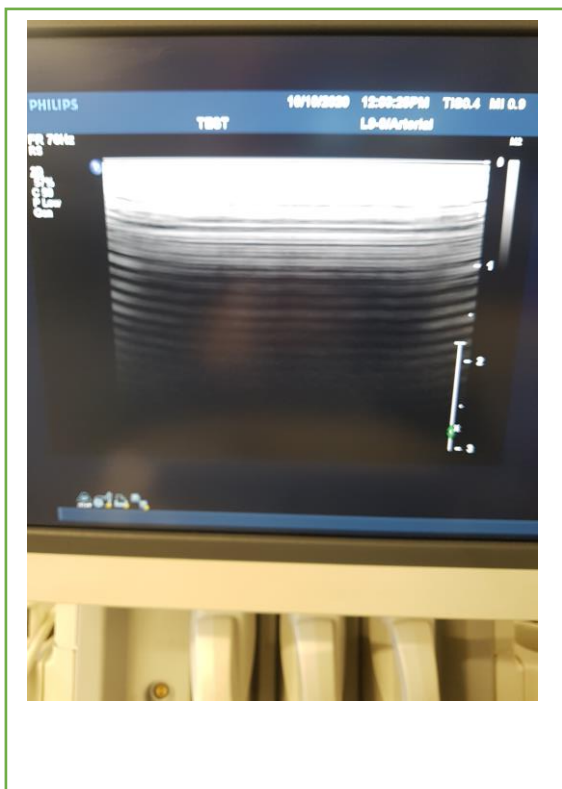
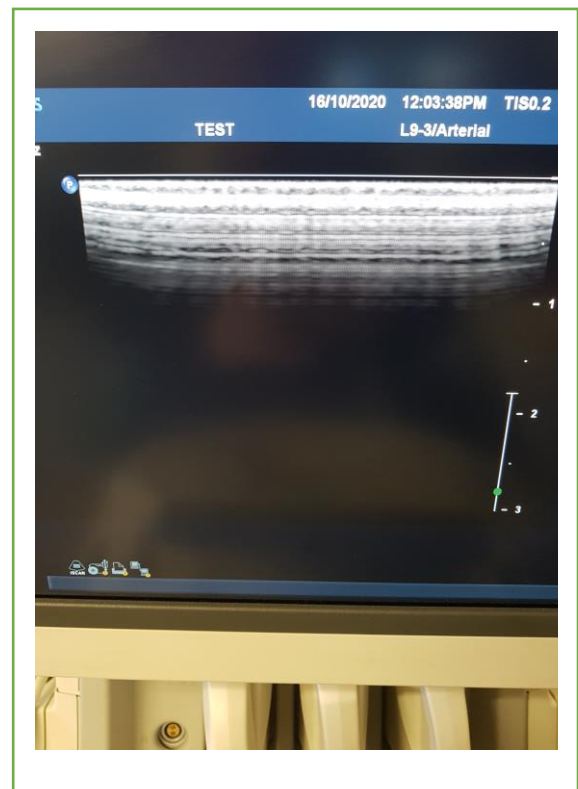
### Airscans –

<b>Date Tested</b> 16/10/2020	<b>Carried out By</b> – I. Rutherford
<b>Manufacturer</b> - Philips	<b>Model Number</b> – L9-3
<b>Serial Number</b> – 03H59K	
<b>Transducer Type</b> – Linear	
<b>Date of Manufacture</b> - Unknown	
<b>System used to Test</b> – Philips iU22	
<b>Cable</b> – Good	
<b>Lens</b> – Good	
<b>Discolouration</b> –Some	
<b>Overall Condition</b> – Good
