## Ultrasound Transducer Condition Report

<b>Date Tested 6/10/2020</b>	<b>Carried out By – I. Rutherford</b>
<b>Manufacturer – GE</b>	<b>Model Number – 9L-D</b>
<b>Serial Number – 131993WP8</b>	
<b>Transducer Type –Linear</b>	
<b>Date of Manufacture – February 2013</b>	
<b>System used to Test – GE Logiq E9</b>	
<b>Cable – Good</b>	
<b>Lens – Good</b>	
<b>Discolouration –Slight</b>	
<b>Overall Condition – Good</b> © British Medical Auctions

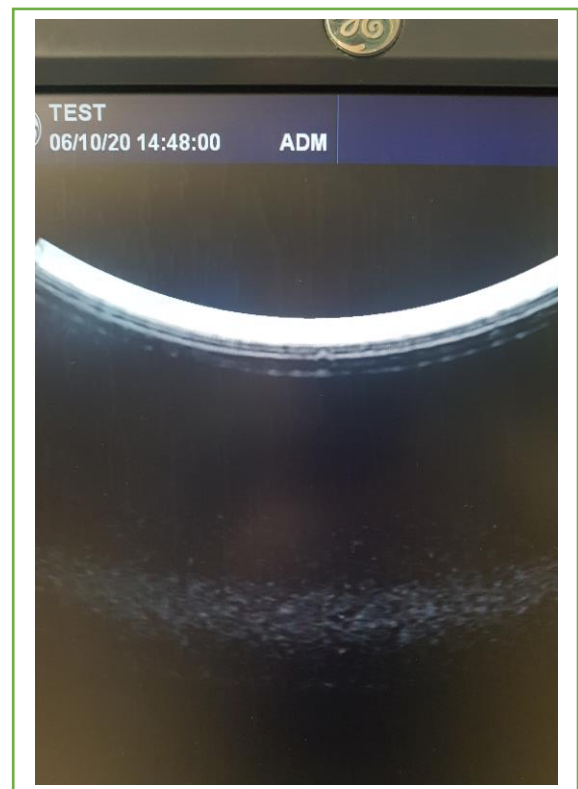
### Airscans –

<b>Date Tested 6/10/2020</b>	<b>Carried out By – I. Rutherford</b>
<b>Manufacturer – GE</b>	<b>Model Number – M6C</b>
<b>Serial Number – 67582YP7</b>	
<b>Transducer Type – Convex</b>	
<b>Date of Manufacture – January 2011</b>	
<b>System used to Test – GE Logiq E9</b>	
<b>Cable – Good</b>	
<b>Lens – Good</b>	
<b>Discolouration –Slight</b>	
<b>Overall Condition – Good</b>

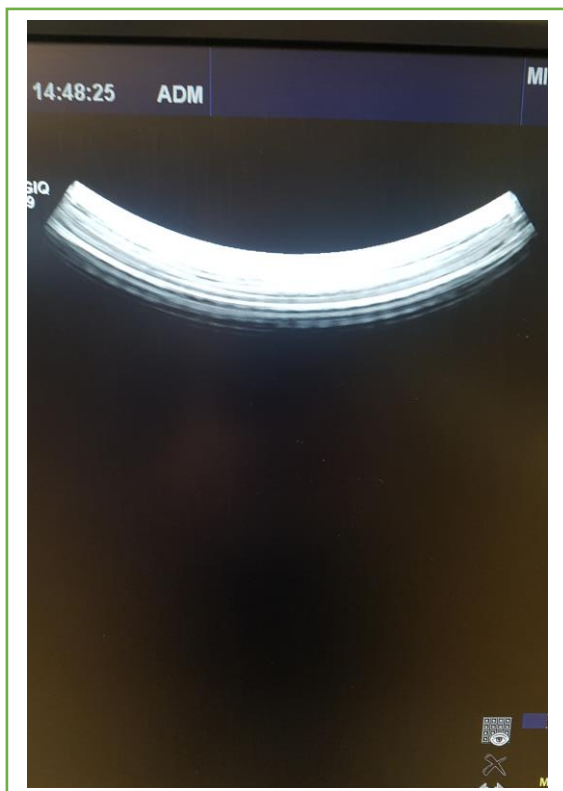
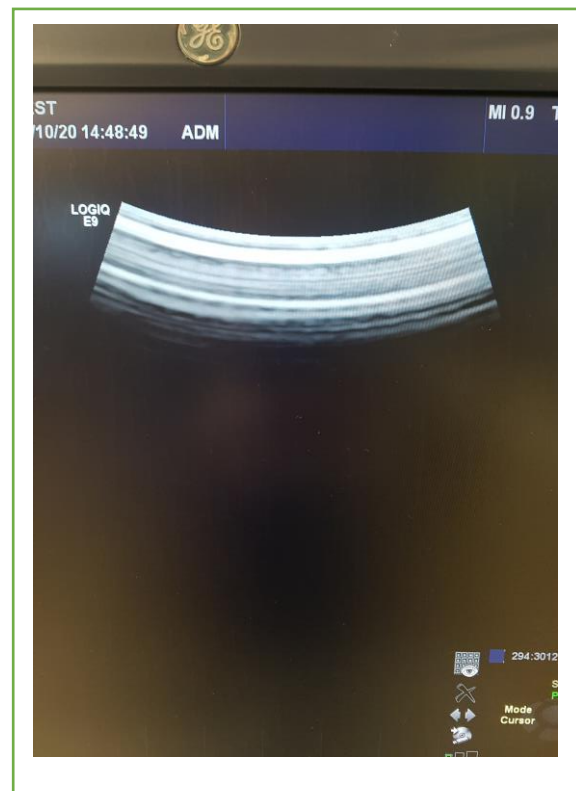
### Airscans –

<b>Date Tested 6/10/2020</b>	<b>Carried out By – I. Rutherford</b>
<b>Manufacturer – GE</b>	<b>Model Number – C1-5-D</b>
<b>Serial Number – 191411YP8</b>	
<b>Transducer Type – Convex</b>	
<b>Date of Manufacture – 2015/11</b>	
<b>System used to Test – GE Logiq E9</b>	
<b>Cable – Good</b>	
<b>Lens – Good</b>	
<b>Discolouration –Slight</b>	
<b>Overall Condition – Good</b>
